Inspecting & Repairing Major Components

"Major components" discussed in this chapter include the press **main cylinder**; front or "resistance" **platen**; **tie rods** or **columns**; **container holder**; and **moveable crosshead**.

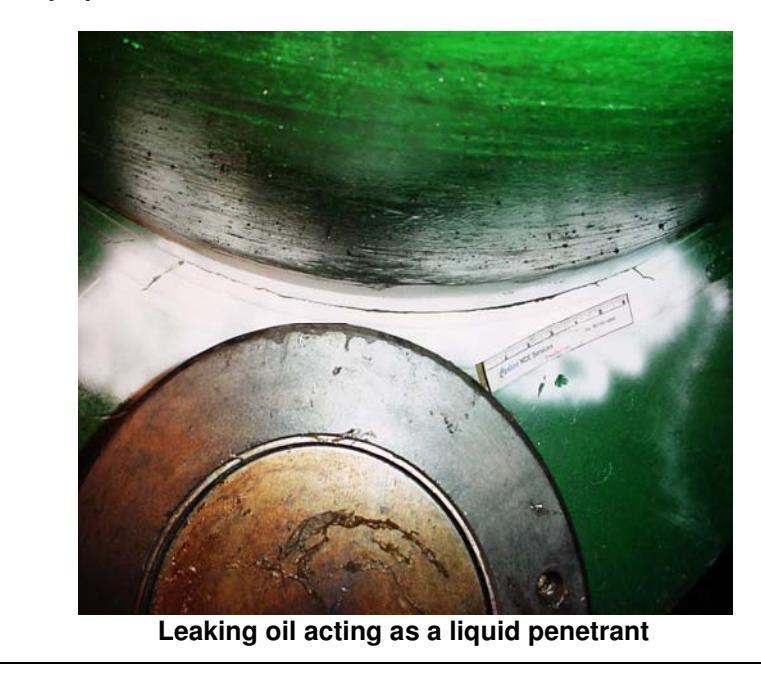
Crack with red dye penetrant

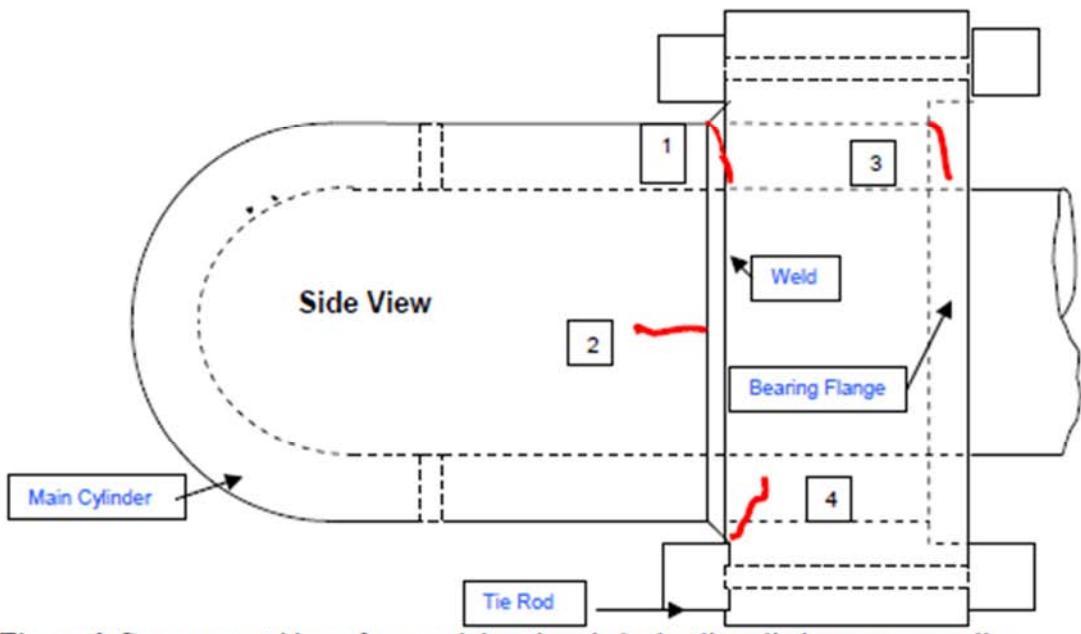
Figure 6. Common outside surface crack locations in hydraulic cylinder pressure walls.

The diagram above (Figure 6) shows the most common locations for outside surface cracks. The picture below shows a liquid penetrant indication of a crack, as diagrammed at Figure 6, Position 1.

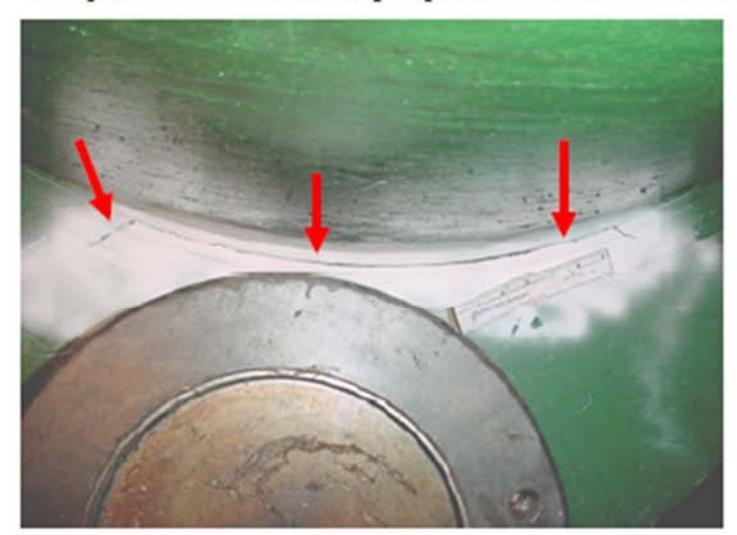
Figure 7. PT indication of a large crack from Figure 6, Position 1.

These cracks initiate at the rear-platen-toshell weld edges on the shell side.

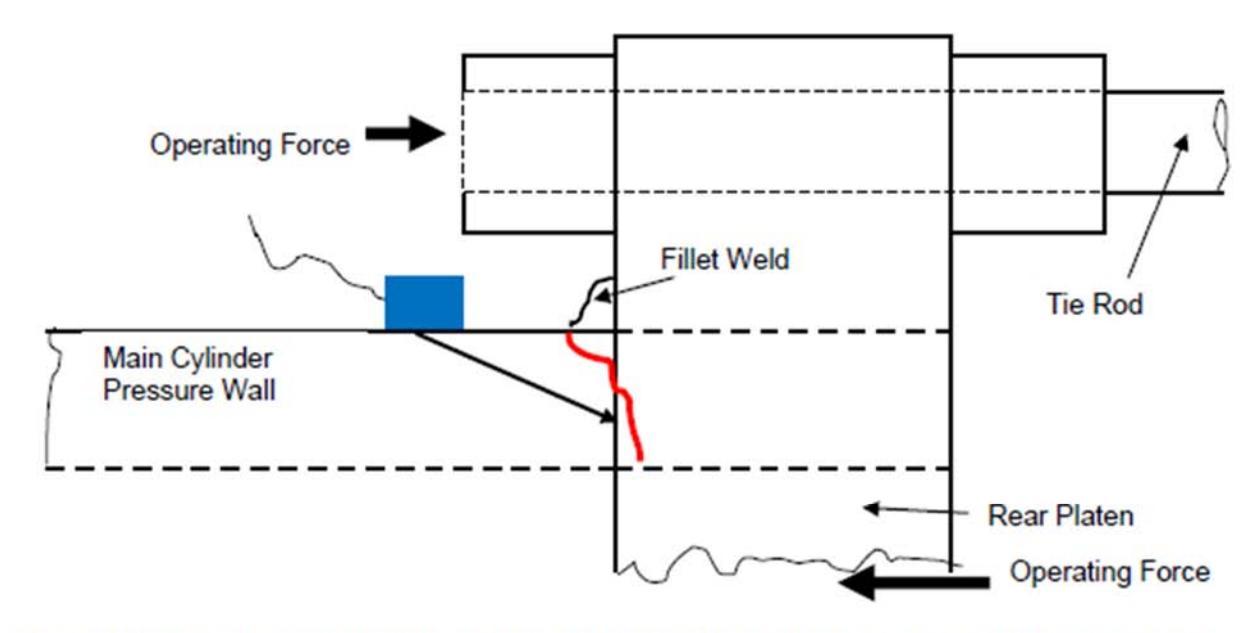
Figure 8. The diagram above shows a more detailed view of the crack shown in Figure 6, Position 1, and in Figure 7. UT angle beam techniques are used to measure the cracks' through-wall depth.

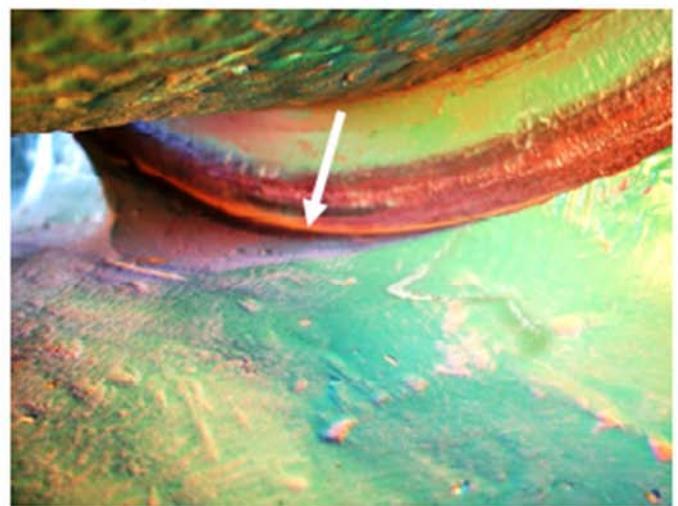
Figure 9. An MT indication of a crack, from Figure 6, Position 4.

Similar cracks initiate at tie rod nut bearing seats, and can propagate into main cylinder pressure walls, shown in Figure 6, Position 4.

The picture to the left shows a magnetic particle indication of an initial stage crack in a tie rod nut seat in a rear platen/main cylinder casting, from Figure 6, Position 4.

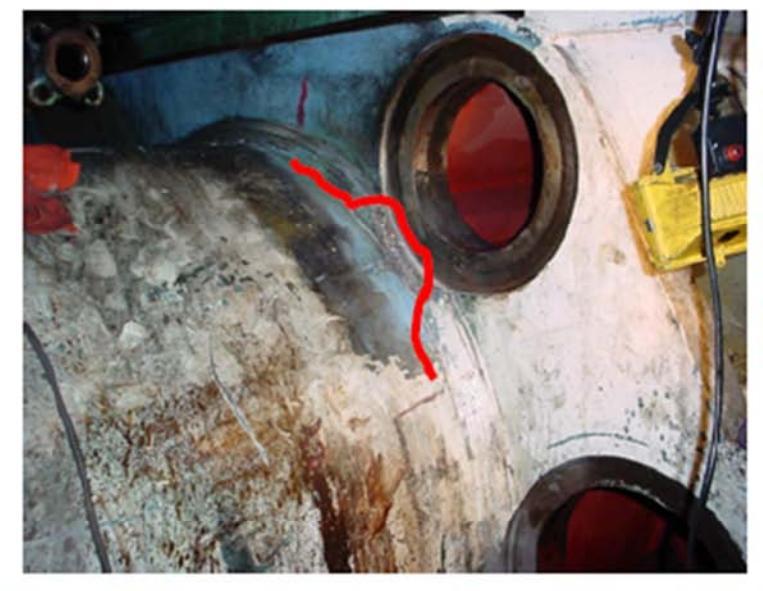
The picture to the left shows an enhanced magnetic particle indication of a large crack that had initiated at the tie rod nut seat (Figure 9), and had penetrated through the pressure wall. This crack occurred in a rear platen / main cylinder, fabricated of a forging and welded steel plate. The crack was excavated away, and the area was repaired by welding in Figure 6, Position 4.

Figure 10. The press shown above was disassembled to repair the through-wall crack highlighted in red.

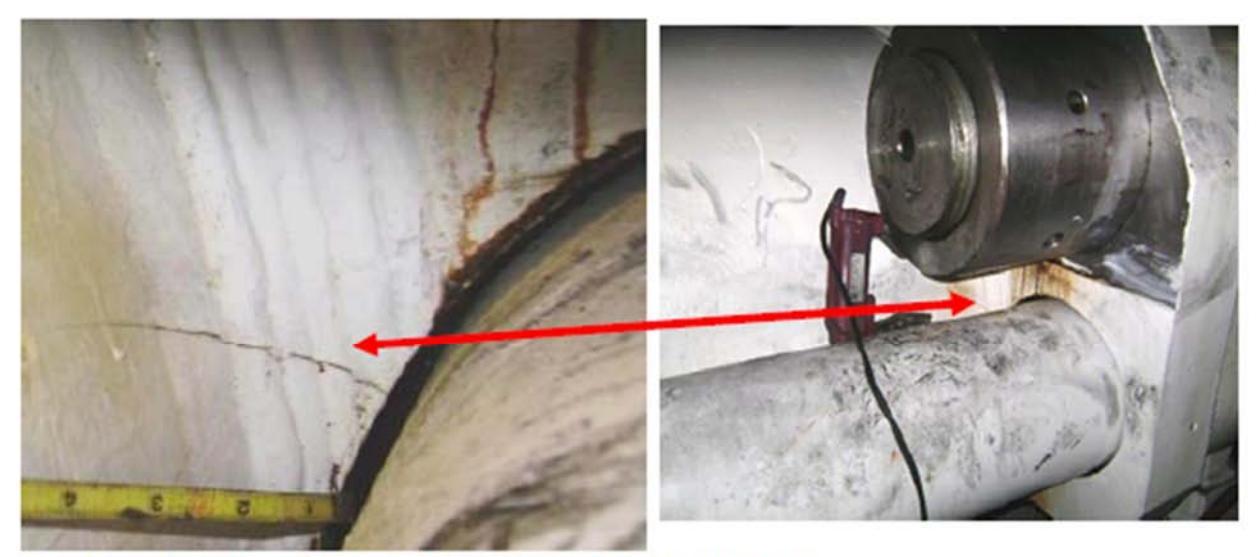
Figure 11. PT indication of a large crack from Figure 6, Position 2.

Cracks, as diagrammed in Figure 6, Position 2, can initiate at corners of side cylinder penetrations in the rear platens. The pictures below show a crack that initiated at a sharp corner, and propagated 30 percent through the thickness of the pressure wall of the main cylinder.

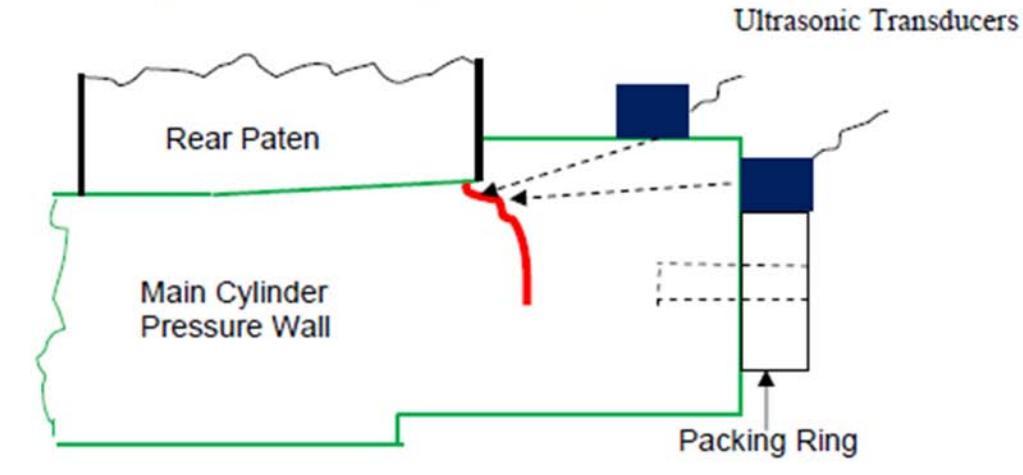
Cracks in load-bearing flanges are detected with UT straight and/or angle beam techniques, applied from the accessible flange surfaces. Initial stage cracks can be oriented at angles other than perpendicular to the pressure wall thickness. In the early stages, these cracks can be resolved with angle beam techniques. Deeper cracks can be measured with a straight beam technique applied from the front face of the cylinder flange. Measurement of deeper cracks requires that the gland packing ring be withdrawn.

Figure 13. Ultrasonic detection of load-bearing flange cracks.

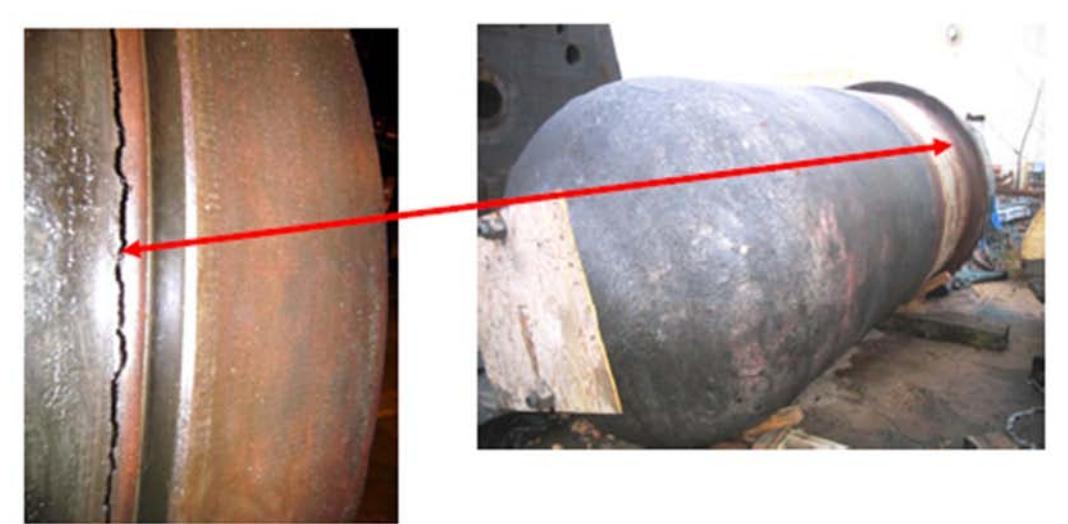
Figure 14. This main hydraulic cylinder had fractured at the flange.

Potential of cracking in this area is heightened by press misalignment, and corrosion.

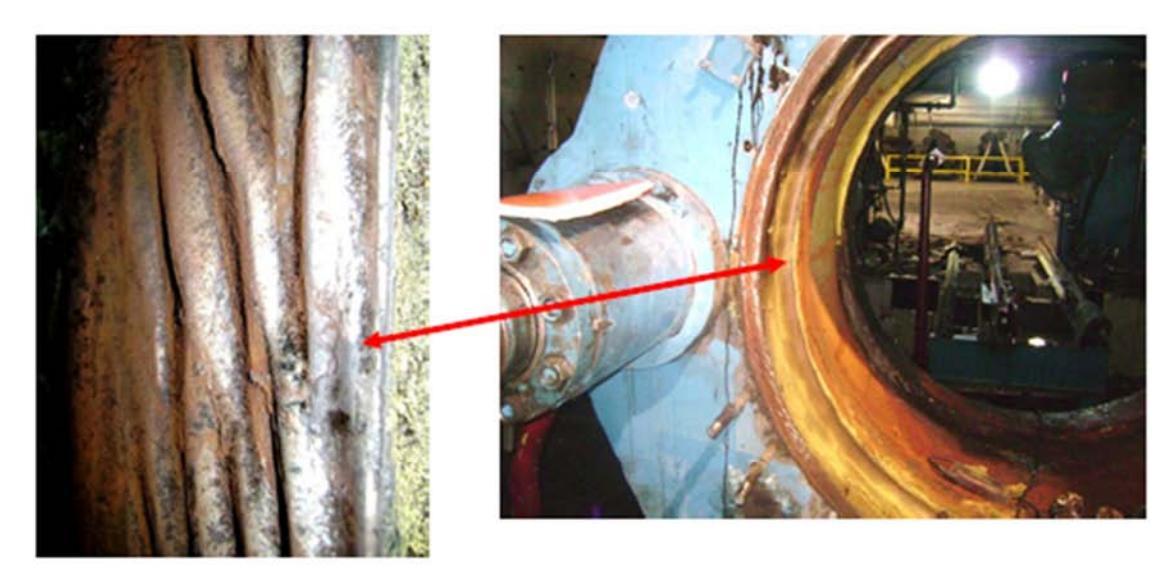
Figure 15. The main hydraulic cylinder was being replaced due to a flange crack. Visual examination of the platen revealed this interesting corroded surface of the main cylinder-to-rear platen bearing surface.

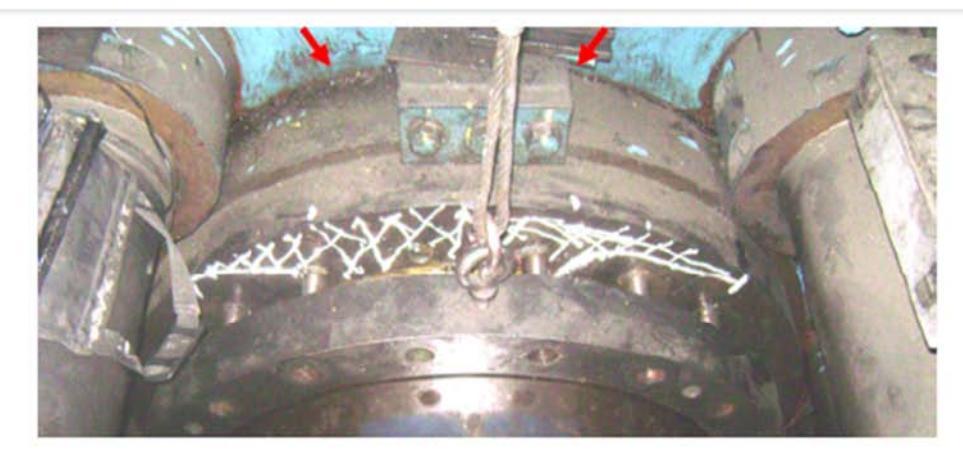
Figures 16a). A through-wall flange crack is mapped on the front face of the main cylinder flange. The gland packing ring had been removed to provide access for a UT straight beam examination. The crack was repaired, and the main cylinder was returned to service.

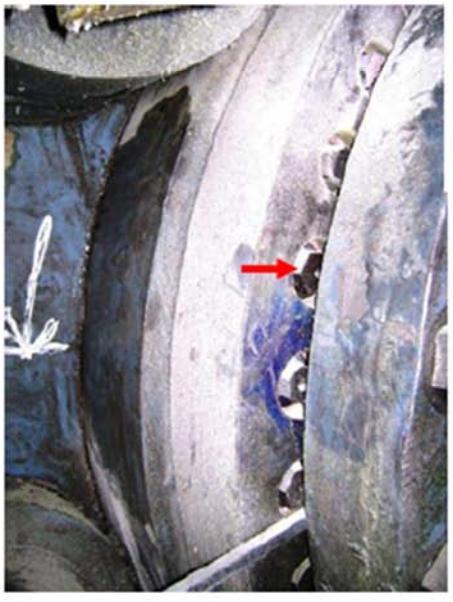
16b) The picture to the left shows a cracked flange that had been repaired. Holes were drilled through the face of the crack, and threads were tapped beyond the crack. High-strength bolts were added to bind the crack.

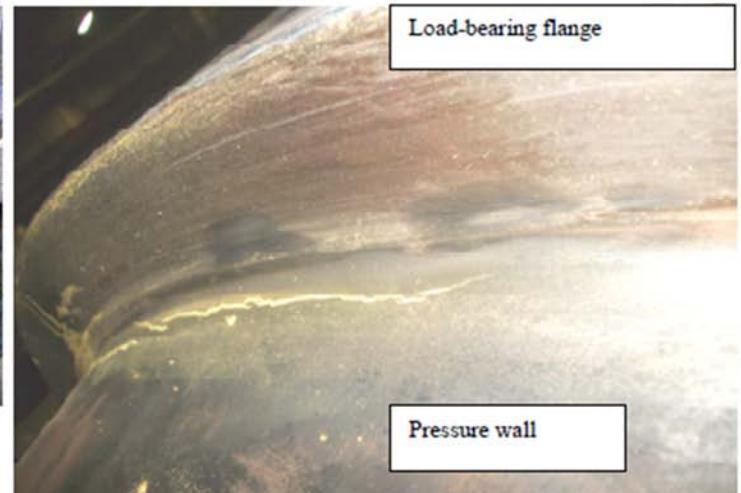
16c) The picture above shows an MT indication of a smaller flange crack.

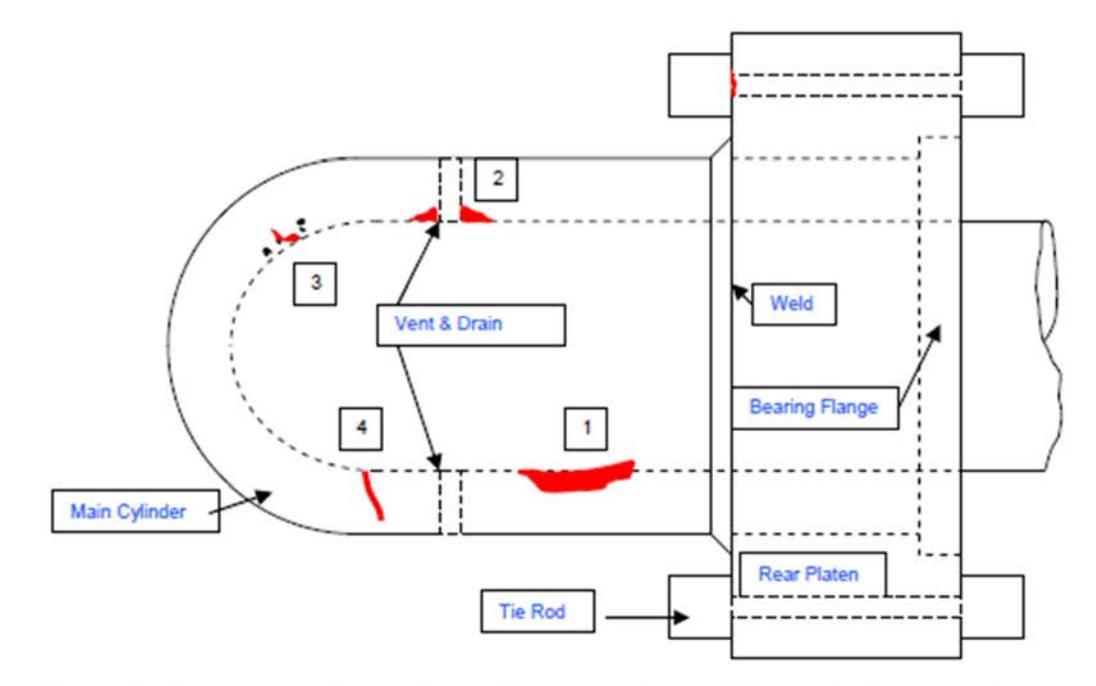
Figure 17. Common areas for cracking at the inner surfaces of the main hydraulic cylinder pressure walls.

Cracks in the longitudinal direction at the inside surface (Figure 17, Position 1) can initiate at casting and welding flaws, or other discontinuities open to, or near the surface. These cracks are readily detectable with UT angle beam techniques applied from the outside surface, and can be accurately measured and monitored for growth rates. Similarly-oriented cracks sometimes initiate at the inner radii of vent and drain holes (Figure 17, Position 2).

Cracks in the circumferential direction (Figure 17, Position 4) can also initiate at discontinuities at or near the inside surface. These cracks are readily detectable in their early stages. It has been our experience that cylinders with flat heads are more susceptible to circumferential cracking at the head-to-shell transition.

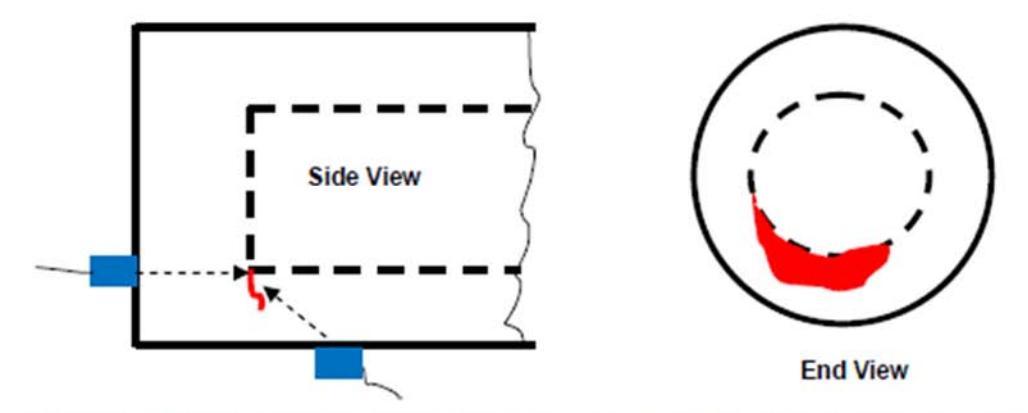
Figure 18. Flat head hydraulic cylinders seem more susceptible to cracking in the circumferential direction at the head-to-shell transition (Figure 16-Position 2).

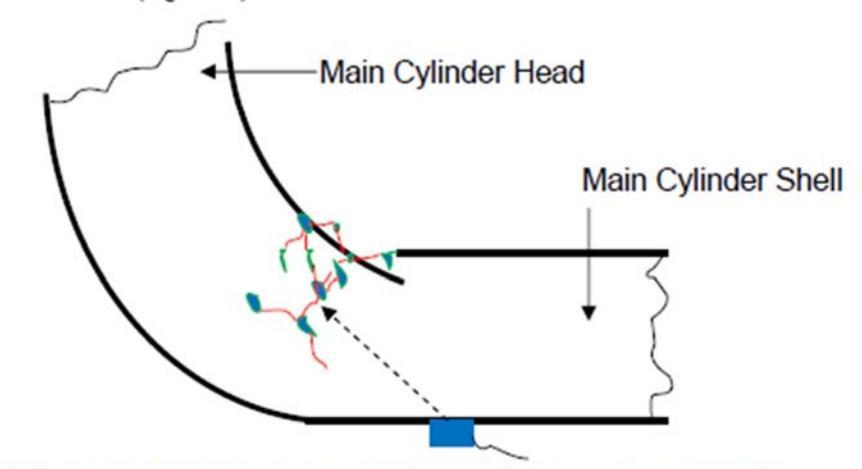
The resultant voids within the pressure walls act as stress risers. Over time, large cracks can develop. Identifying cracks among casting flaws is difficult. Cracks often develop in a *spider web* pattern. Small cracks grow from one casting flaw to another along paths of least resistance (Figure 19).

These cracks are more identifiable with ultrasonics as the press is operating. Cycling loads cause UT indications of cracks to fluctuate. Indications increase in amplitude as the press is loaded, and diminish when the load is removed (Figure 19).

Figure 19. Cracks can develop between casting flaws within cast steel pressure walls.

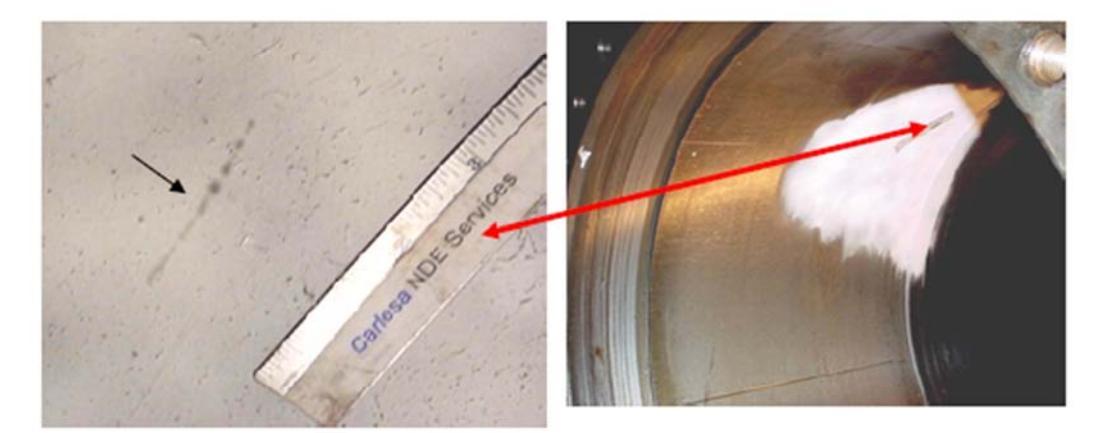
Figure 20. A Liquid Penetrant indication of a crack at the inside surface of a main cylinder pressure wall; the hydraulic oil acts as an excellent indication medium.

It is strongly recommended that if a ram is ever removed from a main cylinder, the complete inner surface of the pressure wall be examined with either the Liquid Penetrant (PT) or Magnetic Particle Testing (MT) method.

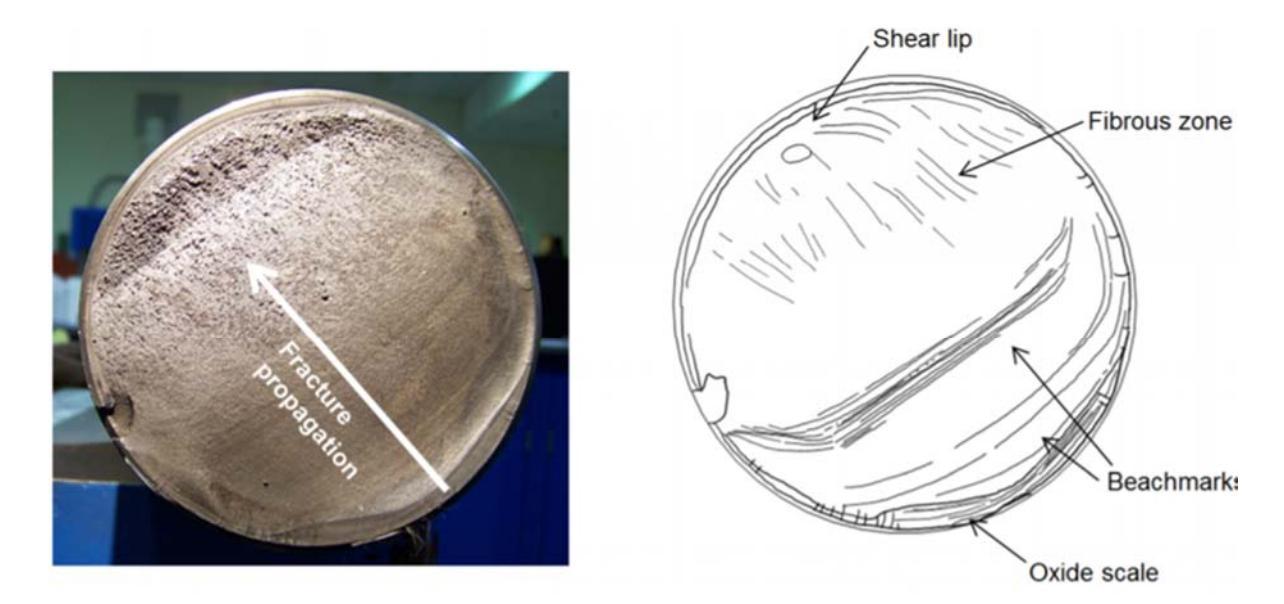
Figure 8. Fracture face and its main elements.

Oxide Scale. This area indicates where the initial crack occurred at an unknown time before the final fracture (this may indicate a weak point in the design of the rod itself).

Stable Crack Growth and Beachmark Zone. The section illustrates stable growth turning into fatigue cracking, then finally failure. When a crack is growing under an increasing load, it displays a concave or convex appearance, depending on the face of the fracture being analyzed.

Fibrous Zone. This large fibrous section is a sign of rapid crack propagation at elevated temperatures.

Shear Lip. This was the final overload that fractured very quickly and most likely at an elevated temperature.²

The origin point for the beachmarks was covered with an oxide film, suggesting exposure to the atmosphere at somewhat elevated temperature. The cracks can be initiated at a wide variety of features, such as scratches, abrupt changes in cross section, tool marks, corrosion pits, inclusions, precipitates, identification marks, and weld configuration defects. In some cases, micro-cracks may be present before loading begins -- for example, grinding cracks, quench cracks, or hot or cold cracks from welding. All these problems increase the likelihood of early failure by fatigue, assuming the presence of alternating stresses of sufficient magnitude. Once that crack is initiated, it can propagate under specific loading conditions like tensile loading and unloading. It is important to

note that the distance between beachmarks close to the crack initiation site is quite high, while the distance between the beachmarks close to the fibrous zone is much smaller.

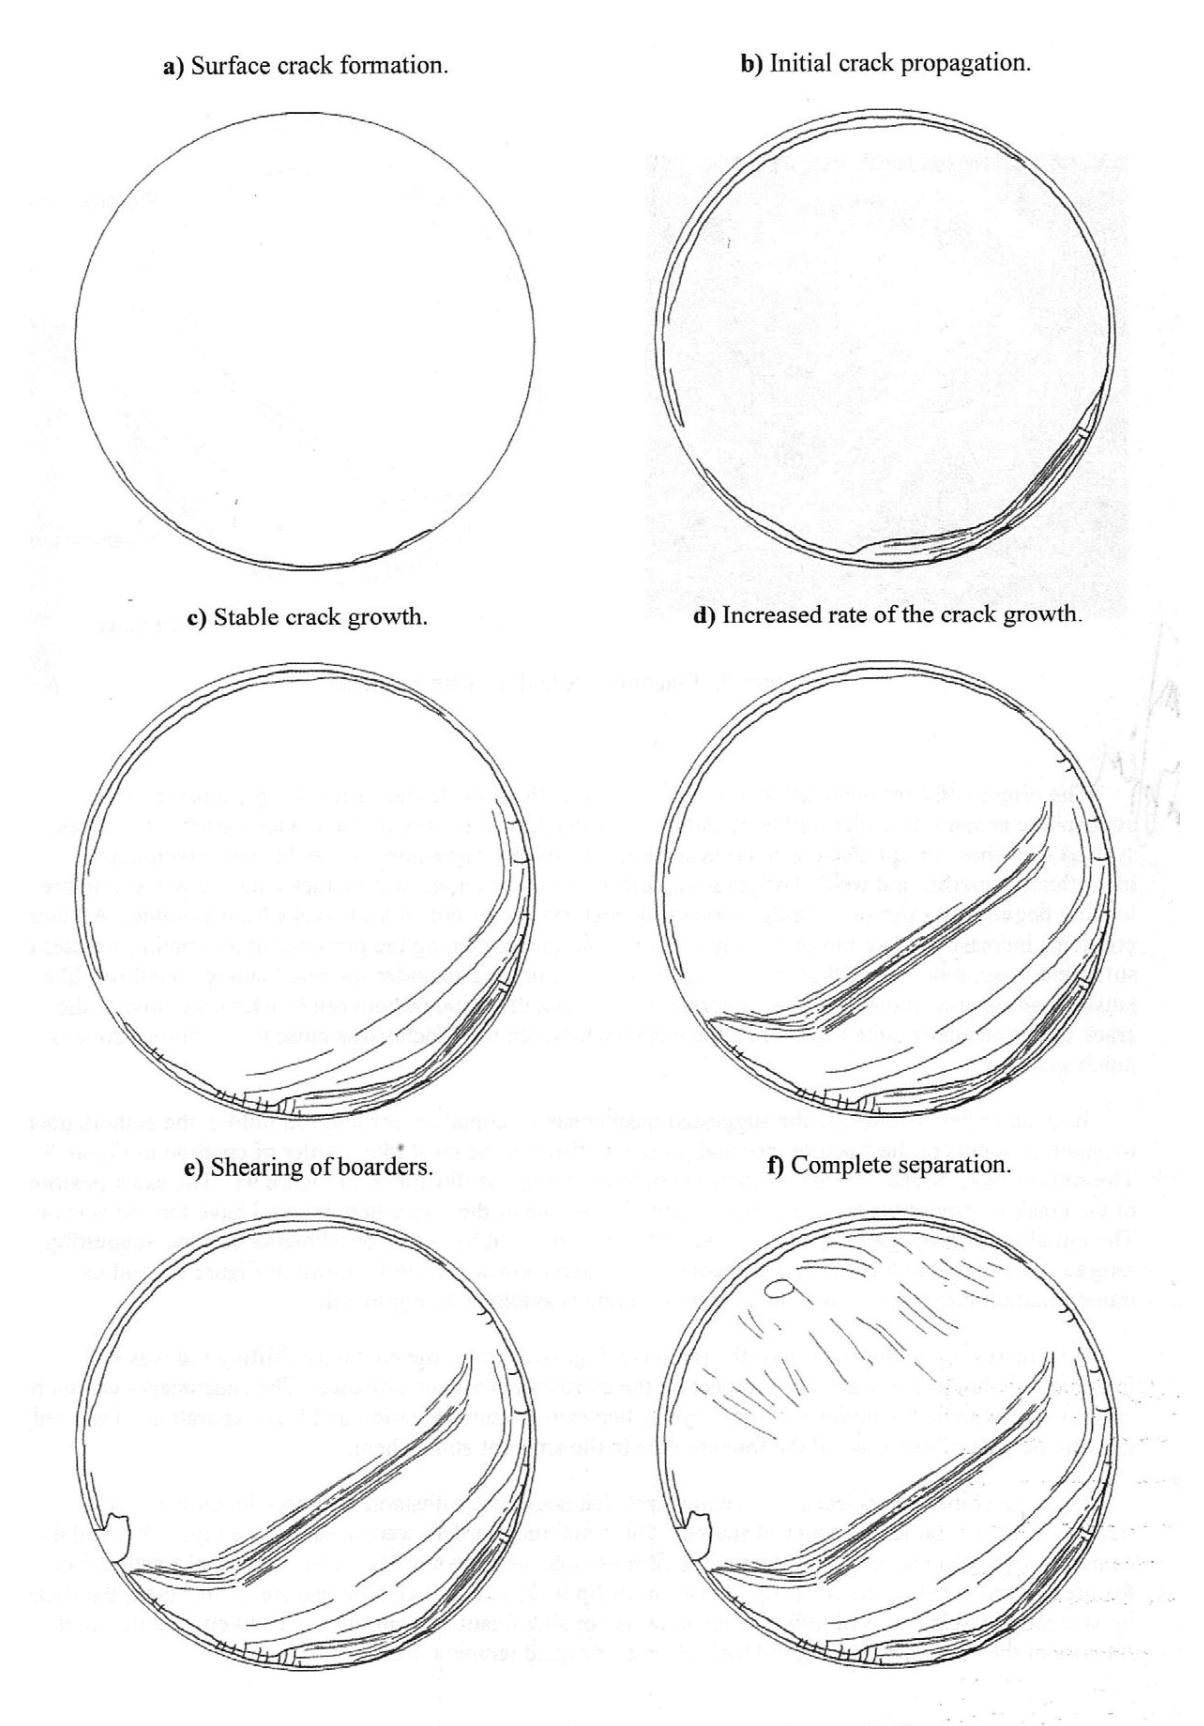
Upon reaching the critical cross-section area that could not withstand any more loading, the final fracture of the container shifting rod started. The remaining borders were sheared (see Figure 9e) and the complete separation occurred producing the fibrous zone, as shown in Figure 9f. The final fracture face feature to form is called the shear lip. Large shear lip is created at high temperature; in this case, the shear lip is clearly visible and well defined; however, is not significant enough. It is very likely that the final fracture of the container shifting rod took place at elevated temperature.

Figure 9. A suggested mechanism of container shifting rod failure.

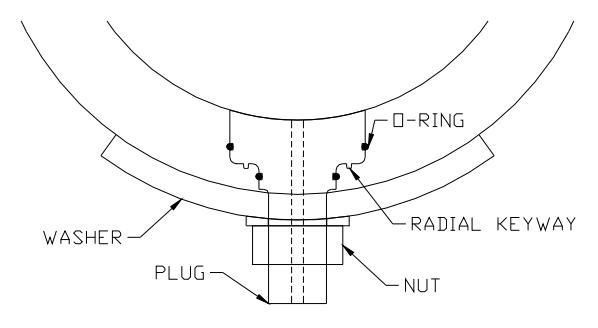
There was only one choice in the repair method due to the size of the crack, its location, and the time required for the repair. After the size of the crack was found with magna-flux testing, a plug and patch system was designed as a temporary fix. The size of the crack through the thickness of the housing was estimated in order to size the plug. The plug was turned and machined out of 11" round 4140 steel stock, and the main cylinder housing was machined from the inside to match the profile of the plug. The housing was machined with a portable boring tool. The plug was then machined to match the milled out portion of the housing. This plug locked itself in place with a radial keyway and

Figure 4-11: Main cylinder housing plug and patch assembly.
