*Chapter 4*

# INSPECTING & REPAIRING MAJOR COMPONENTS

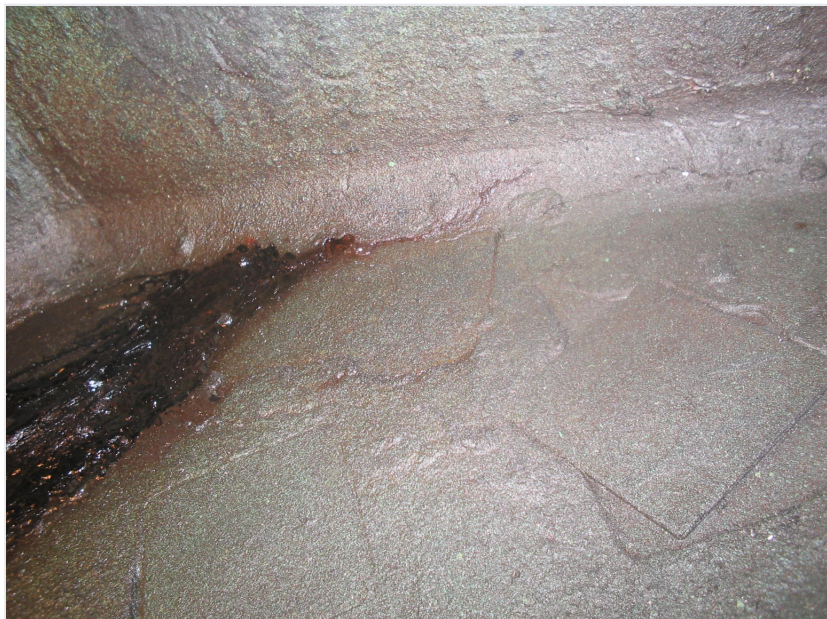
Examples of items found by visual inspection: Loose side cylinder Detached die slide cylinder Oil leak, cracks

**Visual Inspection** is the primary method used for extrusion presses. Look for loose or missing components, oil leaks, or cracks.

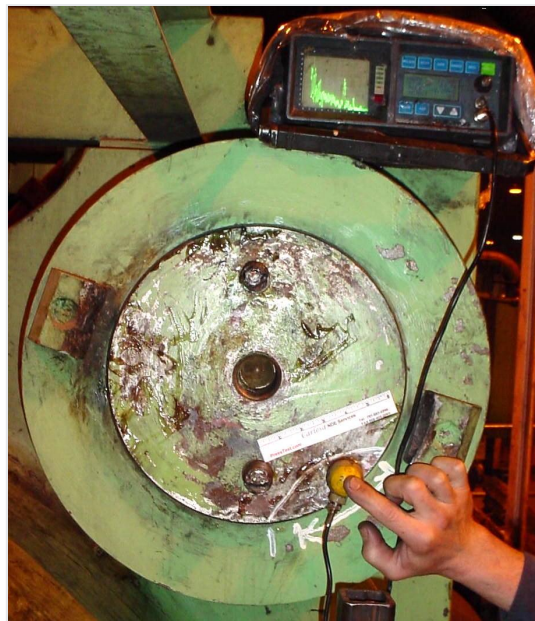
Ultrasonic indication of a tie-rod crack

**Ultrasonic inspection (UT)** is the most sensitive technology for detecting subsurface flaws. It can detect extremely small flaws such as cracks at great depths. It can evaluate the thickness of an object to determine if there is corrosion. Ultrasonic needs only one accessible surface.

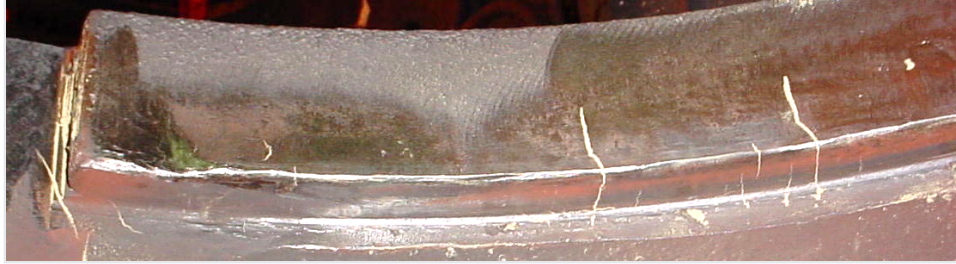
Magnetic particle shows cracks in a hot container housing

**Magnetic particle (MT)** first magnetizes the surface, after which colored magnetic particles are spread over the surface. If there is a crack or other flaw, magnetic particles become attracted to and build up along the area of the defect.

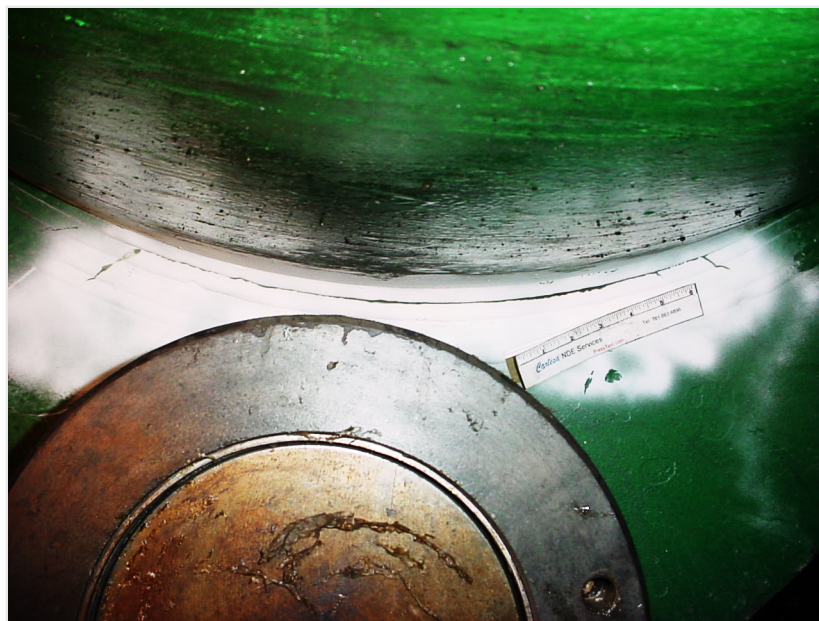
Examples of liquid penetrant (PT) tests Crack with red dye penetrant Leaking oil acting as a liquid penetrant

**Liquid penetrant (PT)** is often used on materials where magnetic particle examination is difficult to use. The examination surface is first cleaned, a red dye is placed on the area of interest, then a white developer is sprayed onto the surface. The developer draws the dye into the surface defects. If a colored dye appears, that indicates the position of the flaw.

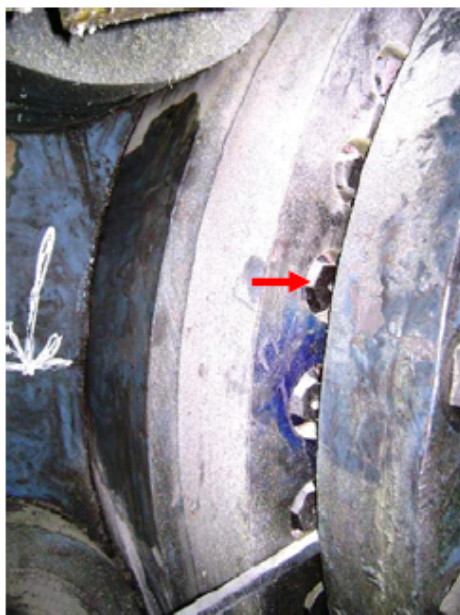
**16b)** The picture to the left shows a cracked flange that had been repaired. Holes were drilled through the face of the crack, and threads were tapped beyond the crack. High-strength bolts were added to bind the crack.

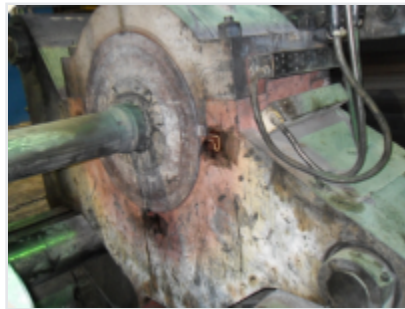
## Container housing

- Problems: loose running, rocking, weld repairs

Container housing structural component:

- Weld repair with OEM or press builder guidance
- Replace with re-engineered fabricated or solid forged component.

Container housing replaceable components:

- Vertical & horizontal guide wear plates
- Container liner
