Inspecting & Repairing Major Components

"Major components" discussed in this chapter include the press **main cylinder**; front or "resistance" **platen**; **tie rods** or **columns**; **container holder**; and **moveable crosshead**.

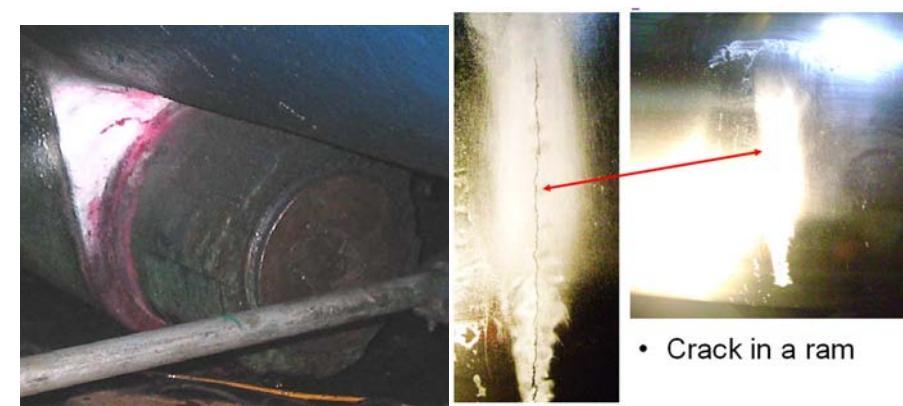
Crack with red dye penetrant

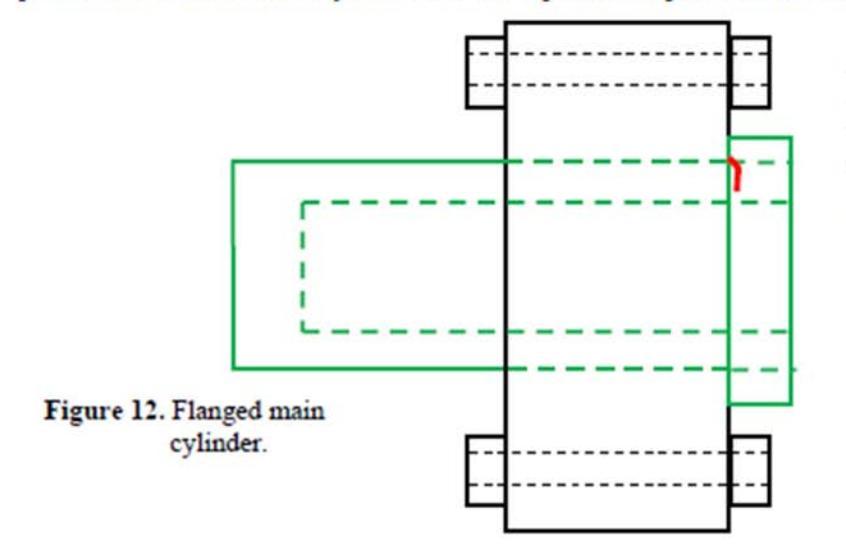
More difficult to detect are cracks that initiate at the load-bearing flanges (Figure 6, Position 3). This problem is limited to main cylinders that are separate components from the main platens.

Cracks in load-bearing flanges are detected with UT straight and/or angle beam techniques, applied from the accessible flange surfaces. Initial stage cracks can be oriented at angles other than perpendicular to the pressure wall thickness. In the early stages, these cracks can be resolved with angle beam techniques. Deeper cracks can be measured with a straight beam technique applied from the front face of the cylinder flange. Measurement of deeper cracks requires that the gland packing ring be withdrawn.

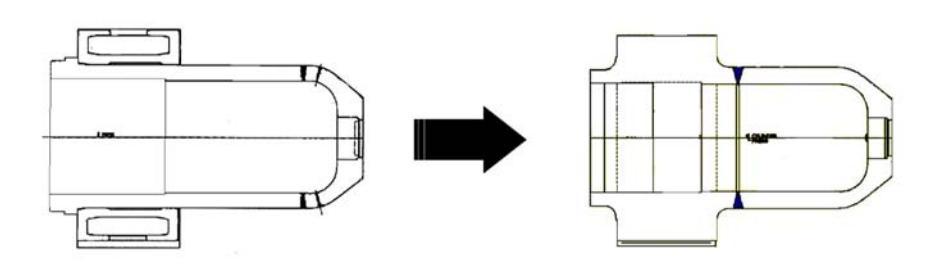
Main cylinder

- Problems: leaks, weld repairs, parallelism, perpendicularity
- Replace casting or fabrication with re-engineered solid forged cylinder.
- Turn inserted bottle into integrated cylinder platen.

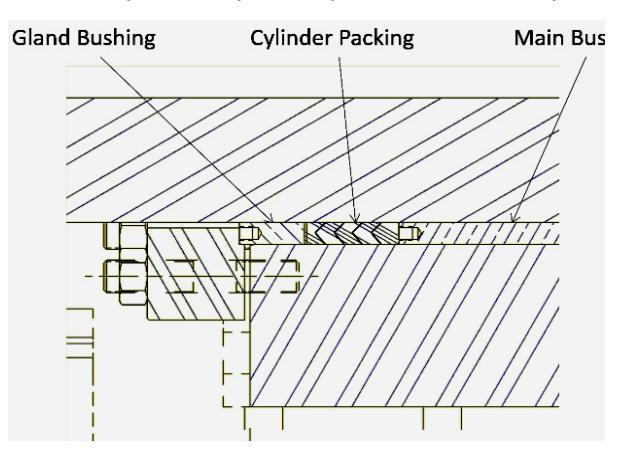
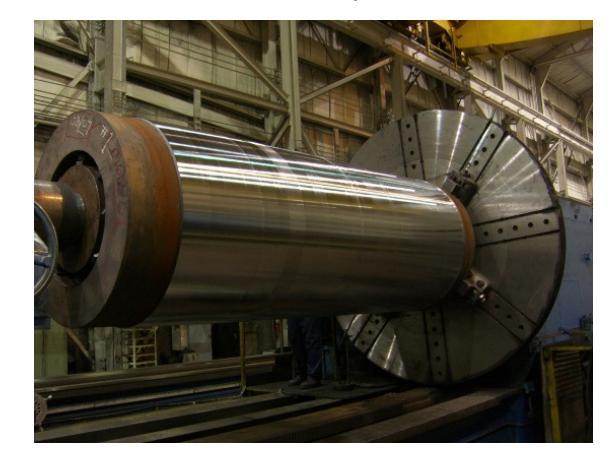
Main ram

- Problems: leaks, scoring, cylindricity, trueness
- Replace with re-engineered forged ram; induction harden if/as required.
- Possible alternative: overlay existing ram.
- May also replace cylinder wear components and crosshead wear components.

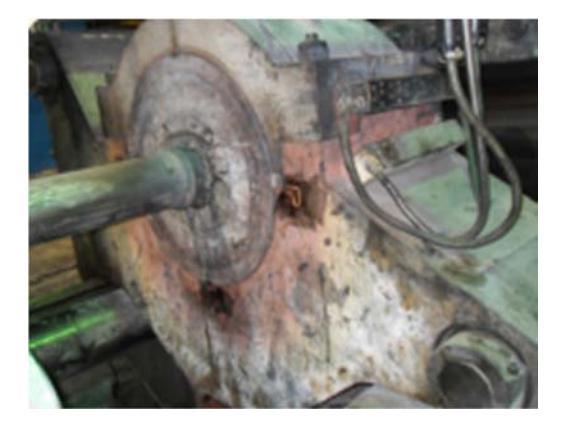
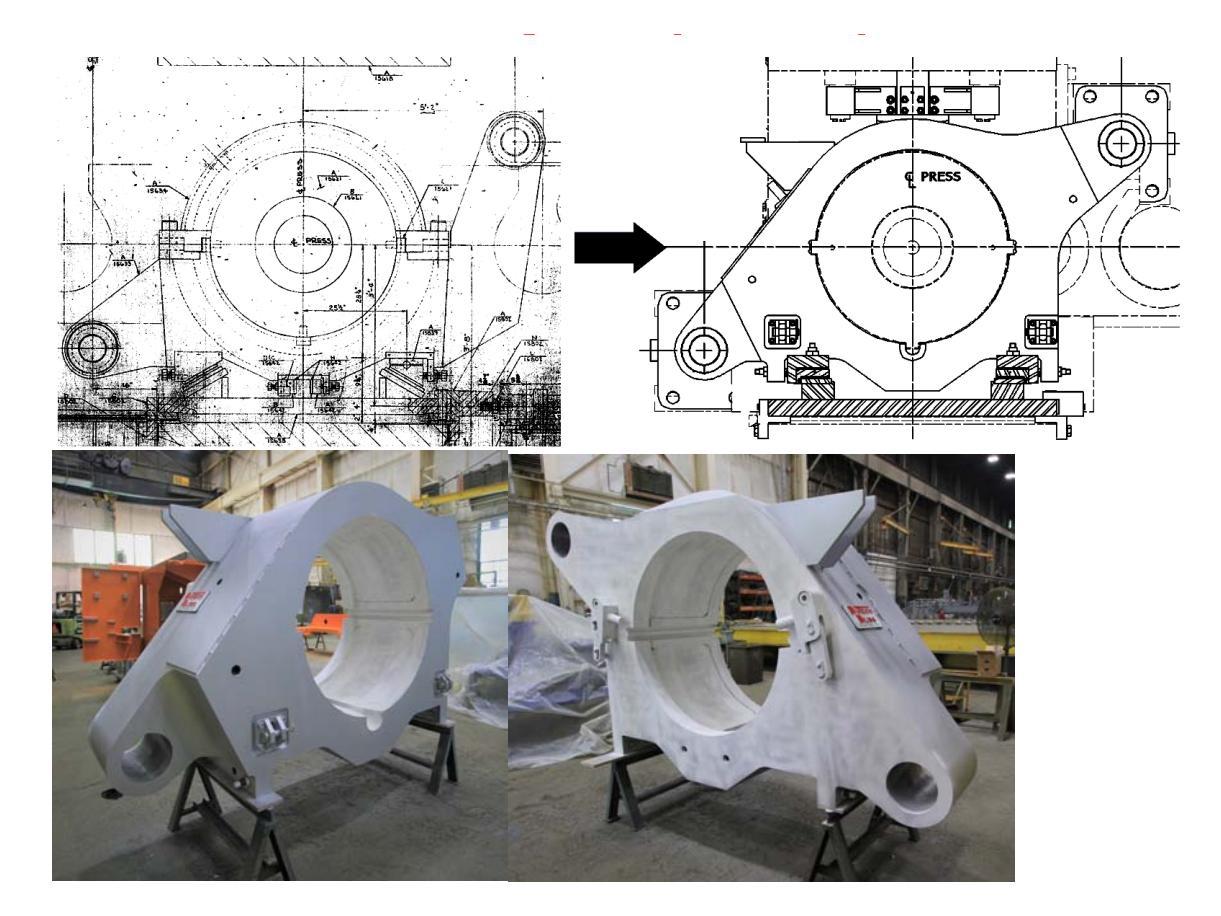
• *Problems: loose running, rocking, weld repairs* Container housing structural component:

- Vertical & horizontal guide wear plates
- Container liner

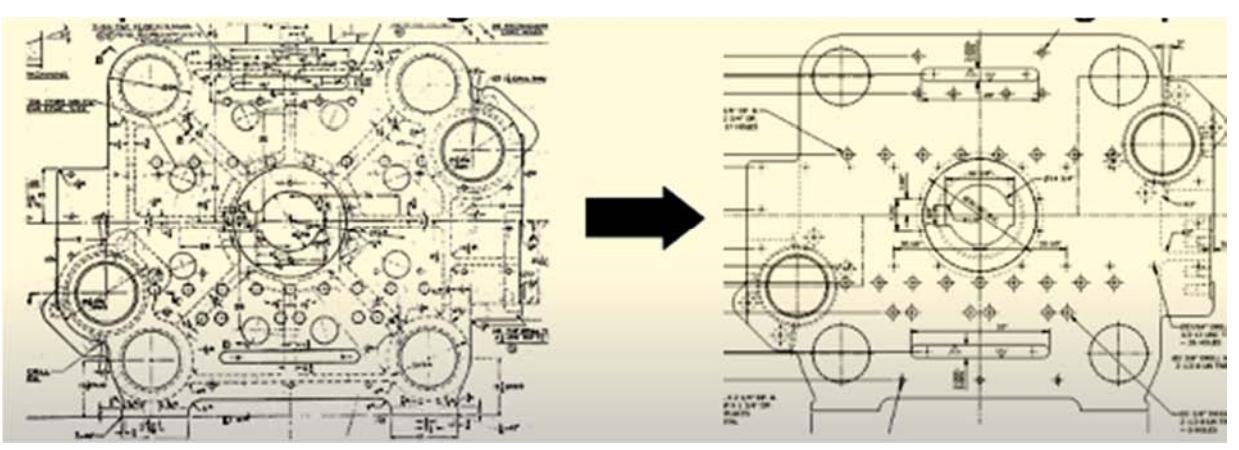
Platen

- Problems: defects, cracks, weld repairs, parallelism; frame interface, pressure plate counter bore
- Repair with frequent monitoring
- Replace with re-engineered fabricated or solid forged platen

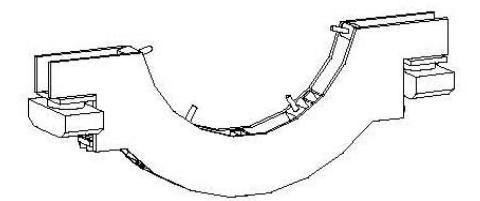
Figure 4-12: Main ram saddle with 4 jack bolts, side guiding cam followers and machine rollers.

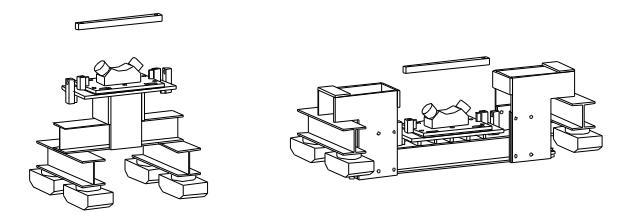
Figure 4-13: Rear truck with top clamp bar (left) and front truck with top clamp (right). Both trucks are outfitted with machine rollers and cam follower assemblies. Each truck has jack bolts controlling vertical and horizontal adjustment.

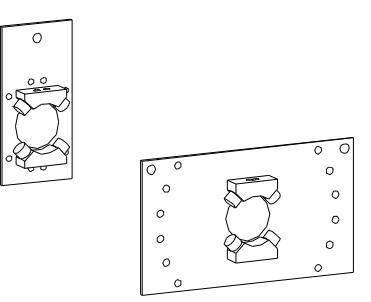
Figure 4-14: Main cylinder housing cam follower plates.

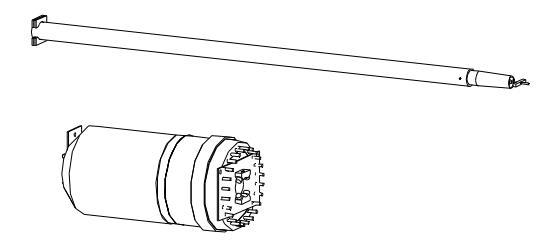
Figure 4-15: 9.5" diameter 1" thick wall steel tube with tapered fitting (above) and main cylinder housing with cam follower plates (below).

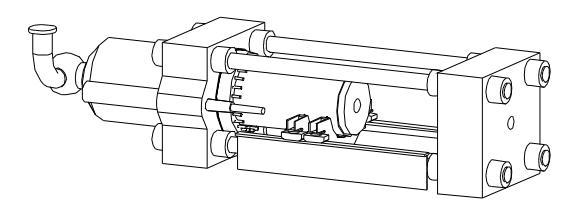
Figure 4-16: After end of ram is blocked up and crosshead is removed, saddles are placed under it.

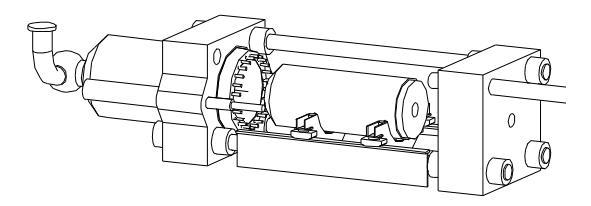
Figure 4-17: Tie rod is shifted and ram is in position to be removed with gantry crane.

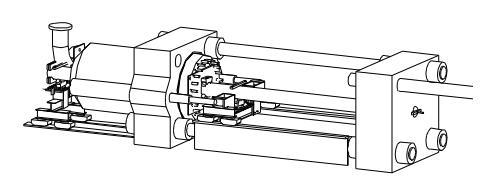
Figure 4-18: Pre-fill valve is shifted and main cylinder housing removal tooling is positioned.

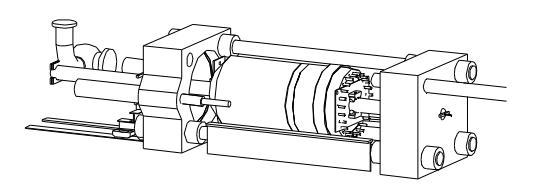
Figure 4-19: Main cylinder housing is shifted into position to be slung by gantry crane to allow for rod removal.
